Title: Geological mapping to assess social and environmental impact of possible slopes instabilities along the Karuma HPP reservoir, Uganda

Dr Stefano Ceriani

Senior Geologist - Hydropower
AFRY Switzerland
Herostrasse 12
8048 Zurich

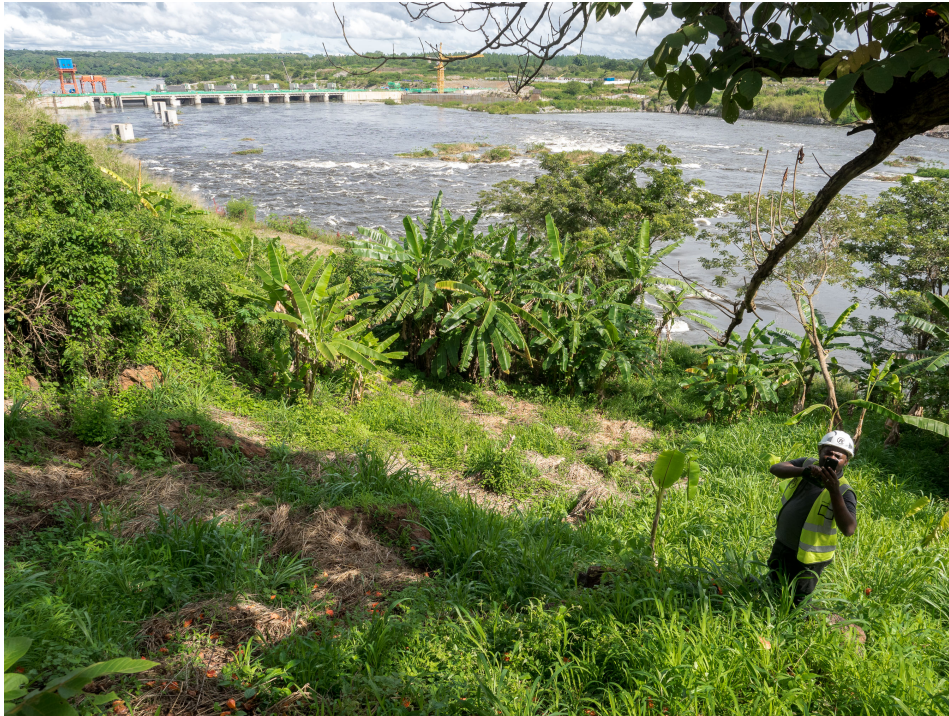
Fig. 1. View of the reservoir slopes immediately upstream of the Karuma dam.

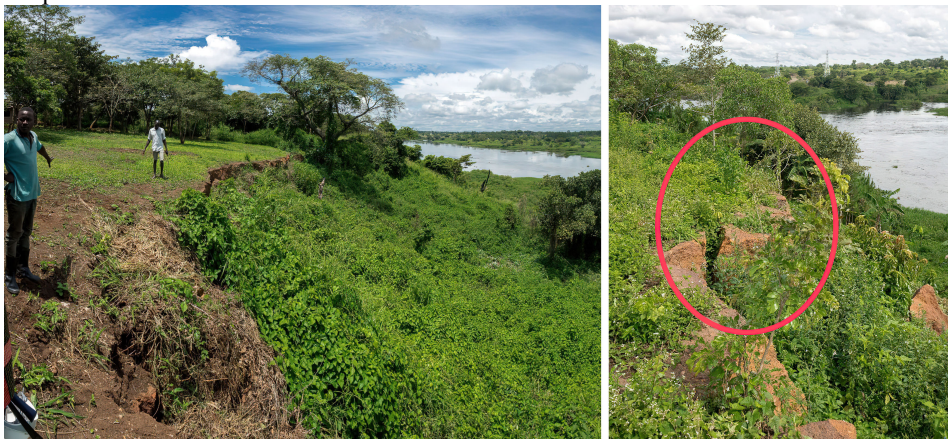
Zone 1: In this zone slopes are generally 15 m to 25 m high, subvertical at the top where the indurated laterite is found and becomes flatter below this hard layer. The inclination of the lower part of the slopes ranges between 35°-45° and 20°-25° and the overall width, from the plateau to the river, is between about 50 m to about 100 m.

The presence of laterite at the water level is excluded because the maximum thickness of the laterite is about 10 m much lower than the height slopes and mainly weathered rocks are expected to form the slope at the reservoir elevation (1028-1030 m asl). This means that the lower and flatter part of the slope is mainly stable but erodible, while the central and upper part of the slope is generally steeper than what the properties of the material would allow because of the presence of the top indurated layer.

Erosion at the base of the slope could induce failures that then propagate toward the cliff potentially also affecting the plateau.

Fig. 4. Left: Stops 34 - 36 Example of wide slope that flatten down toward the base. Right: Stop 2; View from the top of the slope of fallen blocks and tilted blocks

The land close to the slope is here used as a pasture for cattle. Some huts are also present at about 100 m from the slopes (Stop 1) while new buildings were observed at about 20 – 50 m from the cliff including an hospital. Along the slopes itself some small agricultural fields were observed too.

1	Slope failures that can reach the top of the slope	Loss agricultural areas; loss of buildings	2	High for stops 3, 34 and 35 where a hospital is present close to the cliff	Monitoring, Evaluation further investigations and eventually of further remedial measures
2	Localized erosion or small failure along the slope	Loss agricultural areas	2-3	Low to moderate	Monitoring
2	Slope failures	Loss of water spring (Stop 11)	2	Moderate to high for the water spring	Monitoring, Further investigation to better define elevation of the spring and risks of erosion
3	Localized erosion or small failure along the slope	Loss small agricultural area	2-3	Low	Monitoring
3	Slope failures that can reach the top of the slope	Loss agricultural areas; loss of buildings	2	Low in case no buildings are present.	Monitoring
3	Slope failures that can reach the top of the slope	Loss agricultural areas;	2 -3	Low for the agricultural area	Monitoring

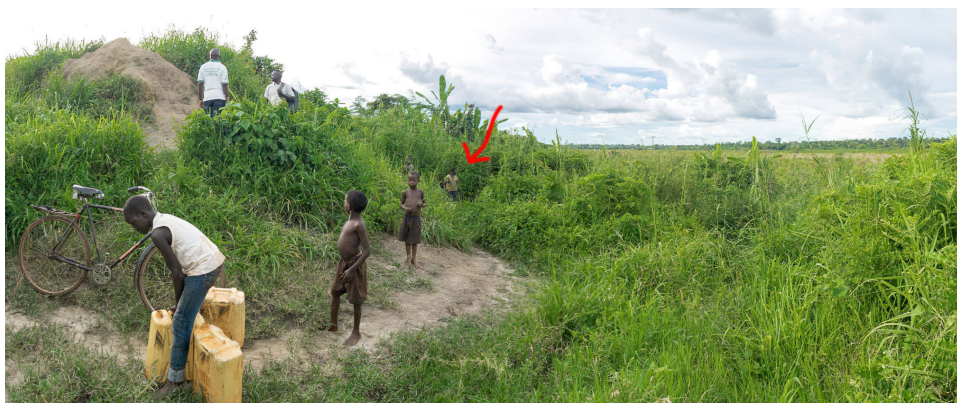
Locally the slope is used for agriculture (banana and other fruit trees) while the shore is covered by papyrus and reeds. A water spring used by locals was located at the base of the slope (Figure 6) and along the edge of the plateau several small villages or single houses are found and most of the land is used for agriculture.

Fig. 6. Stop 11 – Location of the water spring (Red arrow).
